## WELDING INSPECTION REPORT

Resident Engineer: Siegenthaler, Peter **Report No:** WIR-024447 Address: 333 Burma Road **Date Inspected:** 08-May-2011

**OSM Arrival Time:** 700 **Project Name:** SAS Superstructure **OSM Departure Time:** 1900 **Prime Contractor:** American Bridge/Fluor Enterprises, a JV

34-0006 **Bridge No: Component:** Orthotropic Box Girder (OBG)

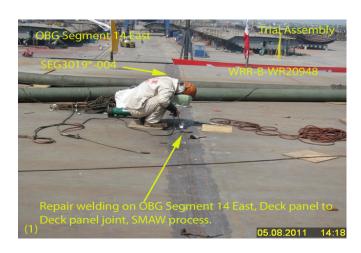
This QA Inspector observed ZPMC qualified welding personnel identified as 066733 Perform Shielded Metal Arc Welding (SMAW) on OBG Segment 14 East Deck panel to Deck panel. Joint identified as SEG3019\*-004. ZPMC QC Identified as Zhu Yuan Yuan with Temporary welding repair report WRR-B-WR20948. The welding parameters as measured using QC's calibrated instrument appeared to be in general compliance with WPS-345-SMAW-1G (1F)-FCM-Repair-1. For more information see below attached picture number 1.

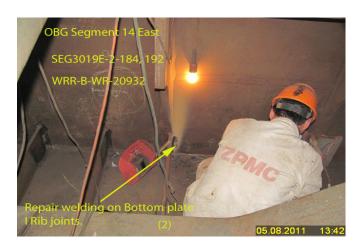
This QA Inspector observed ZPMC qualified welding personnel identified as 054013 Perform Shielded Metal Arc Welding (SMAW) on OBG Segment 14 East. Joint identified as SEG3019E-2-184, 192. ZPMC QC Identified as Zhu Yuan Yuan with Temporary welding repair report WRR-B-WR20932. The welding parameters as measured using QC's calibrated instrument appeared to be in general compliance with WPS-345-SMAW-3G (3F)-FCM-Repair-1. For more information see below attached picture number 2.
